## Chapter 9

# Case Studies of Inadvertent Interactions Between Polymers and Devices in Field Applications

# Case Studies of Plastics Failure Related to Improper Formulation

# Translating Failure Into Success – Lessons Learned From Product Failure Analysis

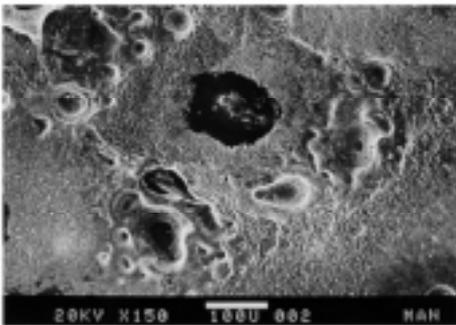
Figure 1 presents a scanning electron micrograph of the surface of a contact removed from a failed switch. On the surface, many melted areas are clearly visible. Some of these are flat, showing the previously molten condition of the metal contacts. Metallographic cross-sections through such a contact showed severe localized melting. Elemental analysis of the contact surface indicated that silver sulfide was present. This compound produced an insulating layer on the surface of the contact, resulting in erratic current flow and localized heating due to limitation of the available contact surface area. Switches in various stages of degradation were operated with thermocouples

Figure 1. Surface of contact showing raised areas where welding occurred, 150x.

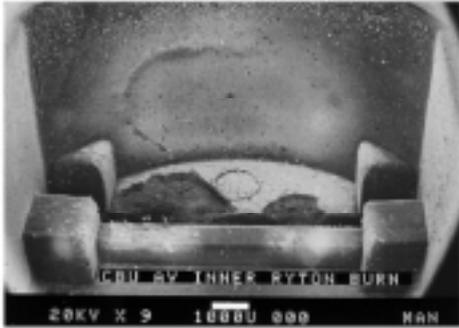
Examination of the switch housing interior surfaces surrounding the contacts revealed significant erosion of the polymer as shown by the light colored oval region in Figure 2. Closer examination

Figure 2. Interior surface of switch housing showing polymer erosion, 9x.

revealed the glass and mineral reinforcement particles within the PPS compound standing in relief, due to polymer pyrolysis. This damage was due to the intense localized heating produced by arcing as electrical contact between the switch contacts was established then broken during normal operation. The combined evidence of contact melting and PPS pyrolysis suggested short-term temperatures in excess of 600°C.

In the case of the thermal limit switch, the choice of materials for the housing inherently led to a reduction in the useful life of the device. The stability and useful life of the switch could be readily enhanced through the use of a polymeric housing that does not produce reactive gaseous products. Many thermoset materials are available, as are ceramics. While the near-term economy of using a thermoplastic material may have appeared attractive, the long-term effect on performance may not have been readily apparent when a material substitution was made.

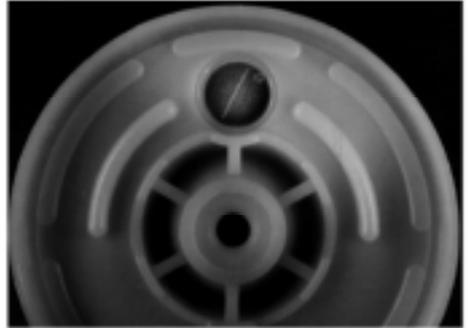
Figure 3. Top view of pressure relief device.

The device was manufactured using a compounded thermoplastic polypropylene which was injection molded into the necessary form. As can be seen in Figure 3 the molded part is quite complex in design; consisting of numerous ribs, radial formations and most importantly, the thin membrane which acts as a pressure rupture diaphragm. The latter is coined in the injection molding process.

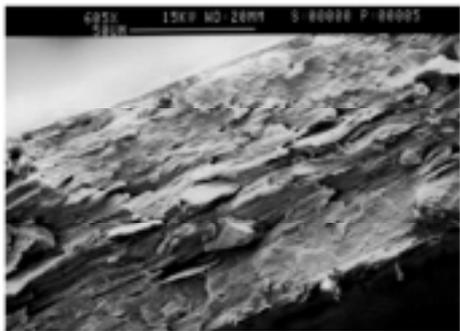
Figure 4. Micrograph of diaphragm cross-section, 605x.

was inconsistent throughout many devices. As shown in Figure 4, the talc particles were quite large when compared with the overall thickness of the diaphragm. As illustrated in this micrograph, the particles aligned in the plane of the membrane and created a stacking effect. In this case, the shape of the particles was inappropriate due to the flow mechanics in the mold cavity. Figure 5 shows the corner at the edge of a representative diaphragm. The filler particles in this area were also dramatically aligned along the curvature of the diaphragm. This suggested that the resin flow in this area during molding was restricted by the presence of the talc particles. This caused the residual stresses in the diaphragm area to be quite high and the particle size of the talc to vary depending on the level of flow restriction during injection.

The effect of the talc particle size variation on the inconsistent performance of the seals was significant. This characteristic mainly affected the flow rheology of the compound under high shear conditions during injection molding. The talc particle size, in comparison to the diaphragm thickness, also led to an erratic influence on the tear characteristics during product performance. Talc agglomeration and absence of bonding with the base polymer further contributed to poor performance.

Inconsistent diaphragm burst performance was caused by a combination of chemical, physical and rheological phenomena. The lots of devices which exhibited a particularly high burst pressure were the result of a very fine particle size talc in conjunction with a low concentration of processing aids. The increased strength of the base resin and lack of large talc particles for burst initiation necessitated high burst pressures. The devices which exhibited lower diaphragm burst pressures suffered from a combination of large talc particles and an absence of lower molecular weight polymer to assist with the flow and wetting of the filler. This resulted in high orientation effects which led to very high residual stresses causing premature failure. These anomalies illustrate the combined effects of the uncontrolled chemical

In the second situation corrective measures were implemented so that predictable and consistent performance of the pressure relief device could be attained. Compound reformulation took place which included the careful selection of a clean homopolymer base resin, a specially designed and compounded antioxidant and a low aspect ratio, small particle size reinforcement. The compound simplification, in combination with highly functional components, allowed for exceptional performance and reliability.

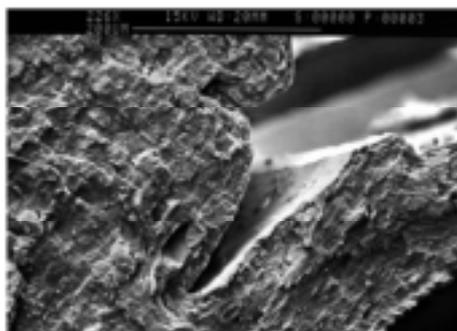
Figure 5. Micrograph of diaphragm corner, 226x.

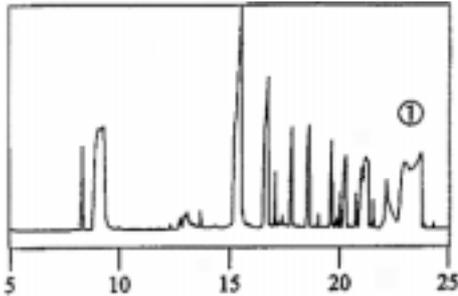
Figure 1. Thermal desorption GC/MS chromatogram of epoxy resin that did not harden. Y axis - ion count; X axis - retention time in minutes. Peak no. (1) - high content of unreacted bisphenol A - diglycidyl ether.

Figure 1 is the chromatogram of adhesive that did not harden. It contains a high content of unreacted bisphenol A diglycidyl ether. Figure 2 shows normal two part resin. The diglycidyl ether (unreacted epoxy resin) is gone and other peaks from the hardener are seen. This analysis provided unequivocal proof that the hardener had been omitted by the customer in the field.

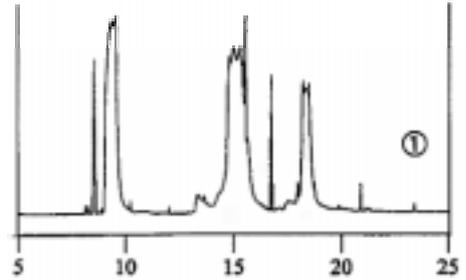
Figure 2. Thermal desorption GC/MS chromatogram of normal two-part epoxy resin that hardened. Y axis - ion count; X axis - retention time in minutes. Peak no. (1) very low content of bisphenol A - diglycidyl ether.

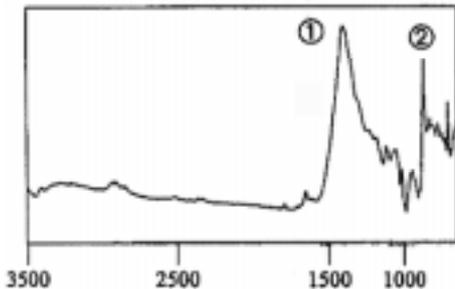
Figure 3. Subtracted IR spectrum of problem tape minus normal tape. Y axis - absorbance; X axis - wavenumbers in  $\text{cm}^{-1}$ . Peaks (1), (2)-calcium carbonate.

Tin coated copper shield over a power cable was held in place by an impregnated fabric tape wrap. Removal of the tape during cable installation caused tin to be removed from the copper shield. Infrared analysis detected calcium carbonate in quantity on both surfaces of the tape, i.e., throughout the tape. Normal tape that did not cause tin to be removed did not contain calcium carbonate. While it is not clear why calcium carbonate would cause the problem, there was no question that it was associated with improper formulation of the tape. Figure 3 was obtained by subtracting the spectrum of normal tape from that of the problem tape. The peaks near 1400 and 900  $\text{cm}^{-1}$  are definitive for the carbonate.

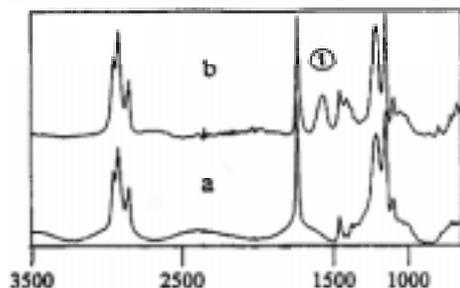
Figure 4. IR spectrum of unused grease (4a) and used degraded grease (4b). Y axis - absorbance; X axis wave-numbers in  $\text{cm}^{-1}$ . Peak no. (1) - new peak in used degraded grease.

Figure 4a is the IR spectrum of unused grease, and Figure 4b is for degraded grease. In 4b, the ester band at  $1740\text{ cm}^{-1}$  is reduced relative to the carbon-hydrogen bands near  $3000\text{ cm}^{-1}$ . A new band formed at approximately  $1650\text{ cm}^{-1}$  due to COOH of carboxylic acid. TD/GC/MS provided further insight into chemical changes that had occurred. Figure 5 is for unused grease. Major peaks are for triphenylphosphate (overload) and a mixture of polyol esters. Figure 6 is for failed grease, showing a much lower content of phosphate and new peaks for heptanoic, octanoic and decanoic acids. The latter formed from partial hydrolysis of the polyol ester. The same GC column and thermal desorption conditions were used as in case 2 above. Figure 7 shows TGA thermograms of unused and degraded grease. The weight loss at  $500\text{--}600^\circ\text{C}$  in 7a is the fluoropolymer. Inorganic ash content was 2% for unused, and 15% for used grease. The higher ash content was shown to contain elements from the screw.

This case illustrates how an additive (triphenylphosphate) can change in service giving a new material (phosphoric acid) which can drastically affect performance. IR and GC/MS were essential in revealing the chemical changes that are responsible for this failure.

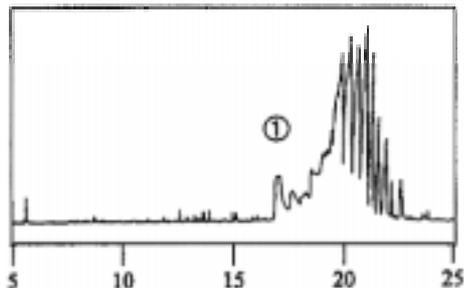
Figure 5. Thermal desorption GC/MS chromatogram of unused grease. Y axis - ion count; X axis - retention time in minutes. Peak no. (1) - triphenyl phosphate (overload).

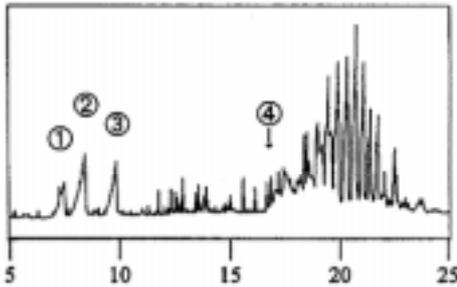
Figure 6. Thermal desorption GC/MS chromatogram of used degraded grease. Y axis - ion count; X axis - retention time in minutes. Peaks (1), (2), (3) - heptanoic, octanoic, decanoic acids; peak (4) - greatly reduced content of triphenylphosphate.

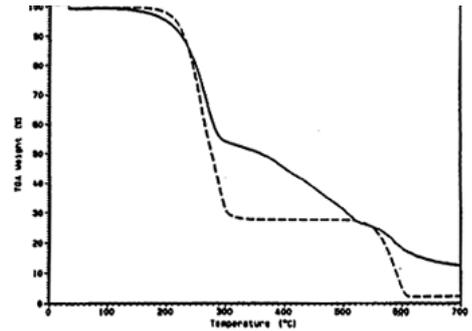
Figure 7. Thermogravimetric analysis of unused grease (---) and used degraded grease (—).

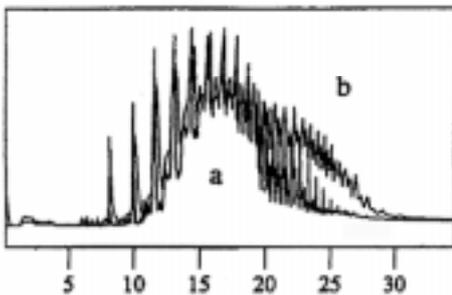
Figure 8. Thermal desorption GC/MS chromatogram of supercritical fluid extract of normal PE (8a) and colored PE (8b). Y axis - ion count; X axis - retention time in minutes.

Supercritical fluid extraction was performed to help isolate from the PE whatever was causing the color. A simple device made here was pressurized to 6000 psi with carbon dioxide at room temperature. 77 mg of PE, first ground to small particle size, was extracted. The CO<sub>2</sub> extract was deposited directly in thermal desorption glass tubes. TD/GC/MS at 350°C gave the chromatograms in Figure 8. Figure 8a (colored PE) shows material at 20-30 minutes GC retention time which

is not present in normal PE. Mass spectral analysis found diglyceride of palmitic acid, and other fatty esters, in the colored PE extract.

The weight percent of material from the contaminated colored PE was so low that only by concentrating it by supercritical extraction was it possible to detect it by GC/MS. Subsequent analysis of candidate recycled PE containing the fatty esters found in the cable in question provided a means of locating the source.

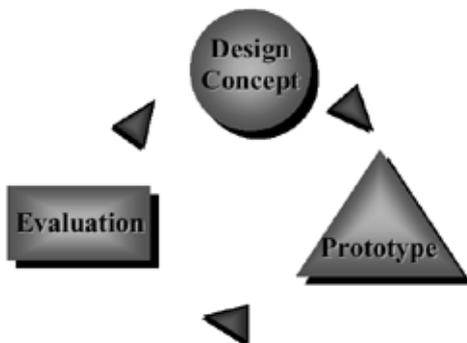
The design process is sometimes illustrated as a circular one (Figure 1) which involves conceptualization of a product, construction of a prototype, evaluation and testing of the prototype, and return to the conceptualization/design phase to correct any deficiencies discovered during testing. Clearly, this is a great simplification, with each one of these phases representing multiple steps.

Figure 1. Schematic of a typical process used in design of plastic components. The product is conceptualized, analyzed, sized and then fashioned into a prototype. The prototype is tested and evaluated and any anomalies revealed are corrected such that the process continues until the final commercial product is realized. Re-design and improvement may continue through the product cycle as appropriate.

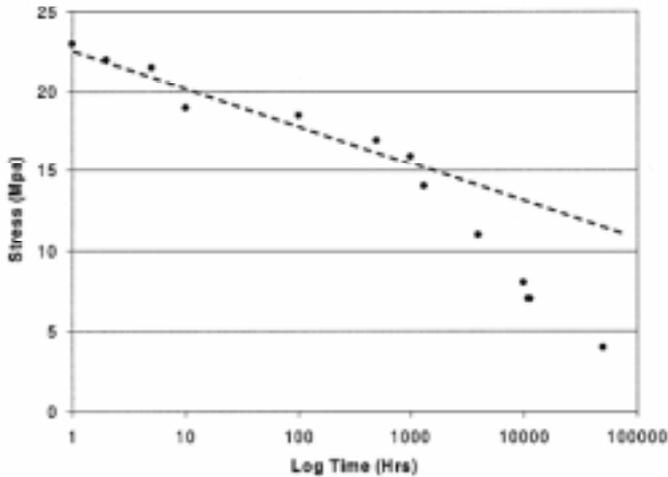
Figure 2. Schematic of curve used to evaluate strength of a product later in its service life. If product is only tested to 1,000 hours and then extrapolated to 100,000 hours as shown, the knee in the curve is missed and strength is overestimated.

time to failure. Higher stress levels fail at lower times and, after application of a safety factor, an extrapolated time is used to define a limiting stress level. More than one pipe has failed because the tester did not consider the change in material behavior, and has extrapolated data erroneously as shown in Figure 2. The standard test methods attempt to limit this kind of problem by forcing the experimenter to have sufficient data for a statistically valid extrapolation.

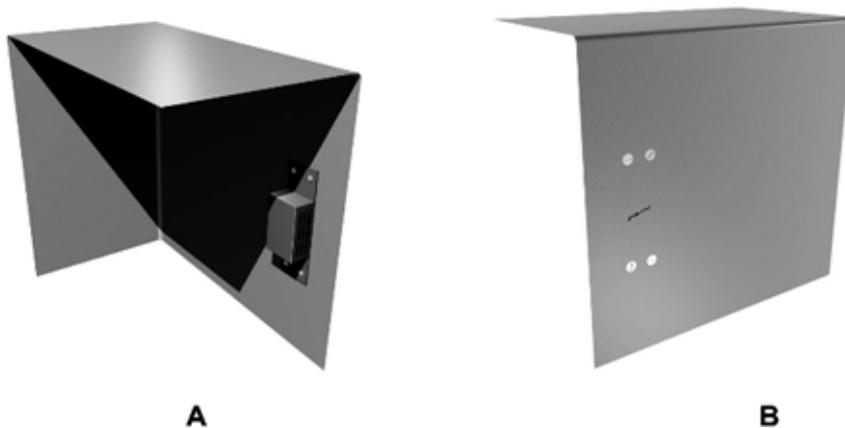
An ABS component housing was found to be cracking with a failure rate of about ten percent. Fracture surface analysis showed that the failures initiated on the inside of the part, thus reducing the concern for external environmental effects. When the interior components were examined, it was found that some of them were metallic and rigidly attached to the

Figure 3. Graphic illustrating failure in a component housing. The metal box, shown in the right side of 3A, was rigidly attached to the housing with 4 screws as seen in 5B. When the part was cooled, restricted contraction of the ABS housing caused tensile stresses to develop that lead to subsequent cracking.

housing. Subsequent experiments revealed that rapid cooling of the housing could reproduce the observed cracking; the metal was restraining thermal contraction of the plastic, causing elevated tensile stresses and cracking (Figure 3). Proper consideration of thermal stresses and end-use testing would have identified and eliminated this failure mode.

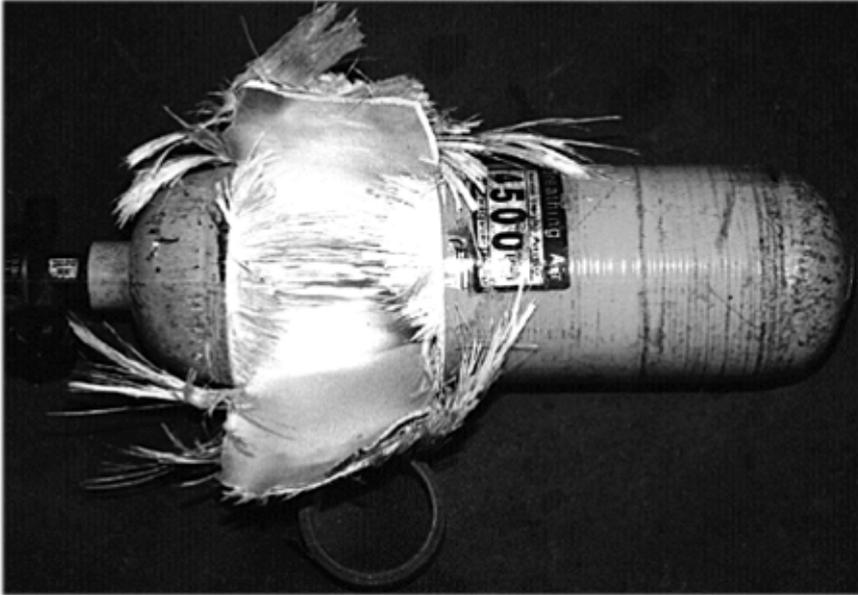
A filament wound fiberglass self contained breathing apparatus (SCBA), with a service pressure of about 31 MPa, ruptured during storage in a fire truck. Inspection of the vessel revealed a regular cracking pattern consistent with stress corrosion behavior (Figure 4). Chemical analysis of the surface showed the presence of acidic (low pH) components found

Figure 4. Photograph of stress corrosion cracking in filament wound fiberglass pressure vessel with an aluminum liner. The fiberglass overwrap failed from stress corrosion cracking after exposure to an acidic substance. Many designers are unaware of the susceptibility of fiberglass to acidic environments.

in aluminum rim cleaners. These compounds can severely stress corrode glass fibers under stress. Many designers are not aware of such stress corrosion phenomenon; we have seen this type of failure several times in the last few years.

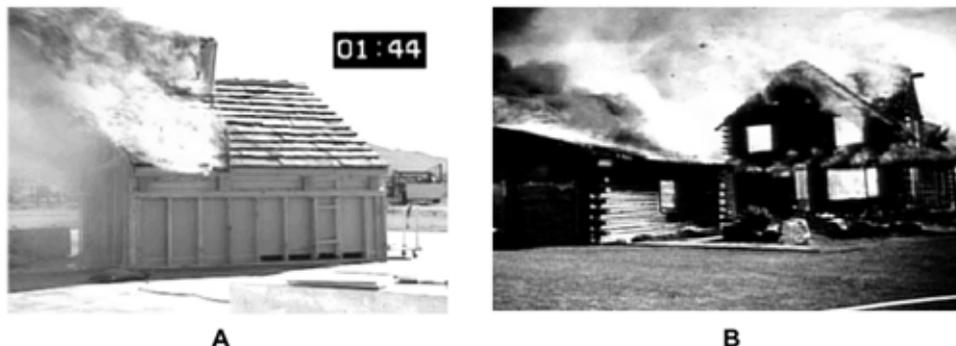
A plastic swamp cooler was designed and constructed by a manufacturer who sought market differentiation from metallic coolers; the plastic device would not rust. The cooler was made from polypropylene and contained an internal pump that was known to fail with regular frequency. In one case, this pump failed and caused the cooler to ignite and initiate a subsequent house fire (Figure 5). This cooler was unmonitored on the roof of a house and contained a known ignition source. It thus represented a perfect candidate for addition of flame retardants; end-use testing would have likely revealed this to the manufacturer.

Figure 5. Polypropylene swamp cooler 1 minute and 44 seconds after ignition from an external flame source (A). The lack of flame retardant in this product lead to the house fire shown in B.
